# Safety Engineering & Risk Analysis Division

3<sup>rd</sup> Quarter 2008

#### Fire Investigations: Why Motorcoaches May Burn (A Mechanical Analysis)

Article Submitted By: Christopher W. Ferrone  
ARCCA, Inc.  
Chicago, IL  
Cell: 773.858.4941 / Tel: 312.676.2960  
Email: cferrone@arcca.com

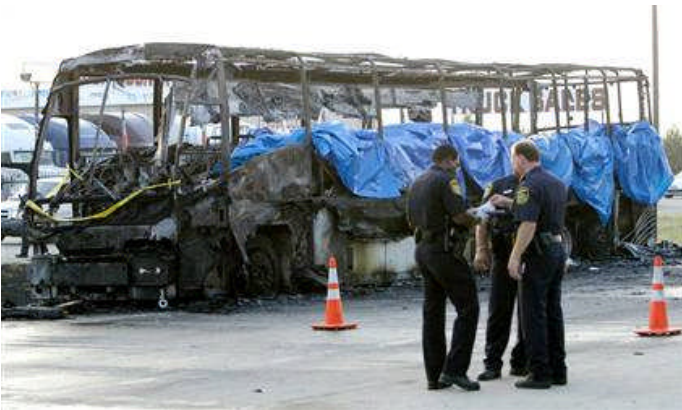
As simple as it appears, if the vehicle is in motion certain items are valid as possible causes. Likewise, if the vehicle is stationary with the engine on or off other items become potential causes. In either case, the situation is dangerous and costly in both human life and property (Photo 1).

Photo 1: Motorcoach involved in fire during Hurricane Rita evacuation (September 24th 2005)

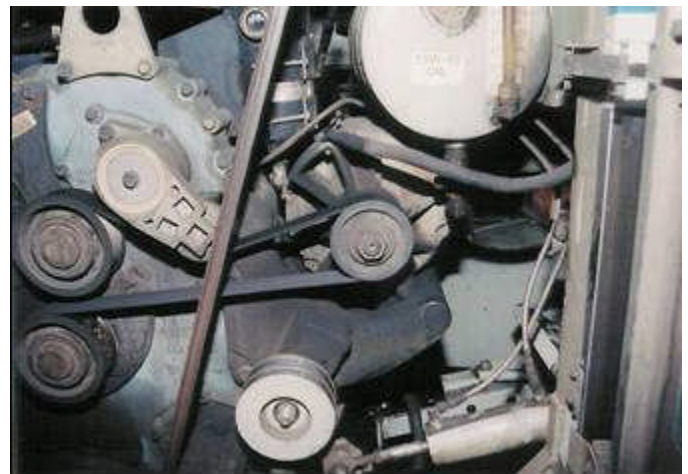
Photo 3a: 50-DN, Series 60

Typically with a 50-DN installation (Photos 3a & 3c), the B+ (direct battery feed) cable is routed to a large stud on the back of the alternator. This in turn is held in place with a nut (to the stud) along with various clamping methods to secure the cable end from any movement (Photo 4).

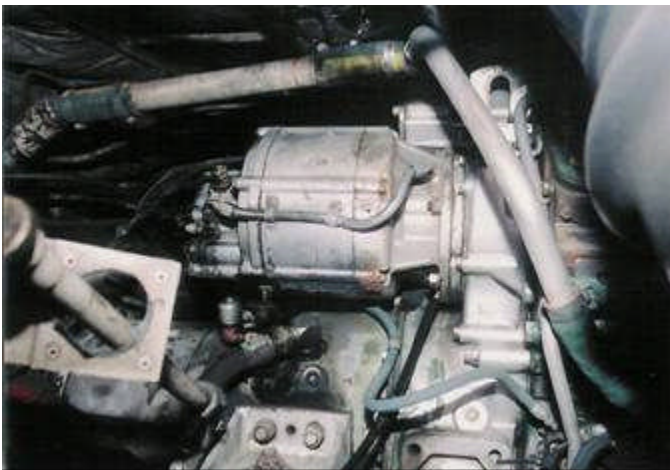
Photo 3c: 50-DN, Series 92

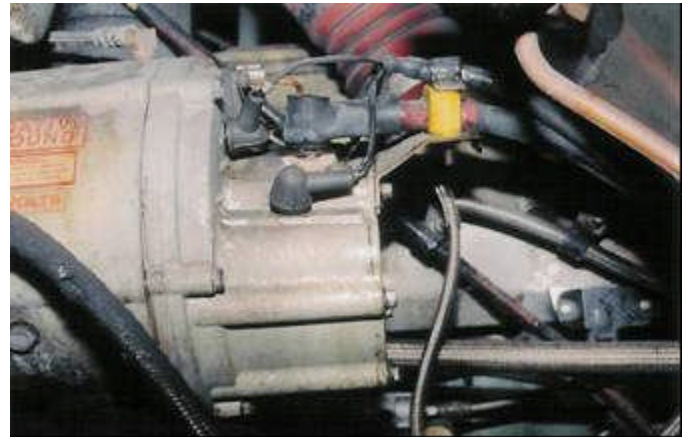
Photo 4: 50-DN, Series 60, MCI Installation

These connections must be quality checked after the alternator has been installed and inspected periodically as well as to ensure there is no movement. It is noteworthy to point out that with some applications, these cables may need to be temporarily removed to facilitate other non-alternator related repairs. The same care and vigilance should be used whether alternator or other repairs are being made. If the B+ cable is loose, it can, by its own weight either fail the plastic insulator material surrounding the stud at its base, internal to the alternator, or wear through the cable insulation locally and make unwanted contact with the support bracket. When this occurs the cable can act similarly to an arc welding machine and cut its way through the bracket (Photo 5).

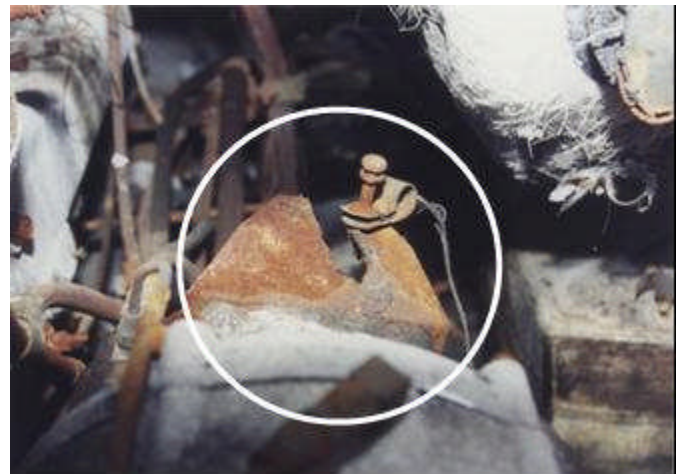
Photo 5: 50-DN, B+ Bracket, Series 60

Once the B+ cable end is free, the cable can drop, making contact with a ground source, resulting in a sustained duration spark. This is exceptionally critical in that with some engine applications the alternator is installed above and on the fuel side of the engine.

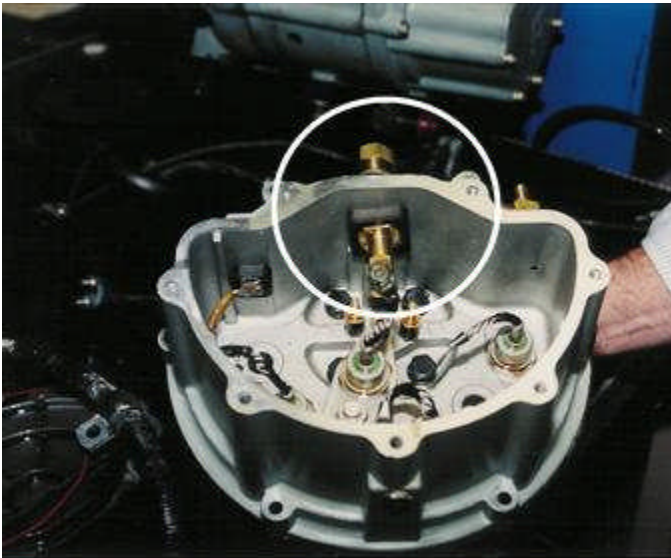
In addition to the cable and its mounting system there is another potential fire hazard. When installing the B+ cable to the stud (50-DN) the proper torque must be used to ensure that the plastic material (internal insulator) is not broken or compromised in any way (Photo 6a). If this nut is over-torqued, or otherwise installed incorrectly, it could lead to a loose stud subsequently leading to an ignition source and fire (Photo 6b).

Photo 6a: 50-DN, B+ Stud Insulator

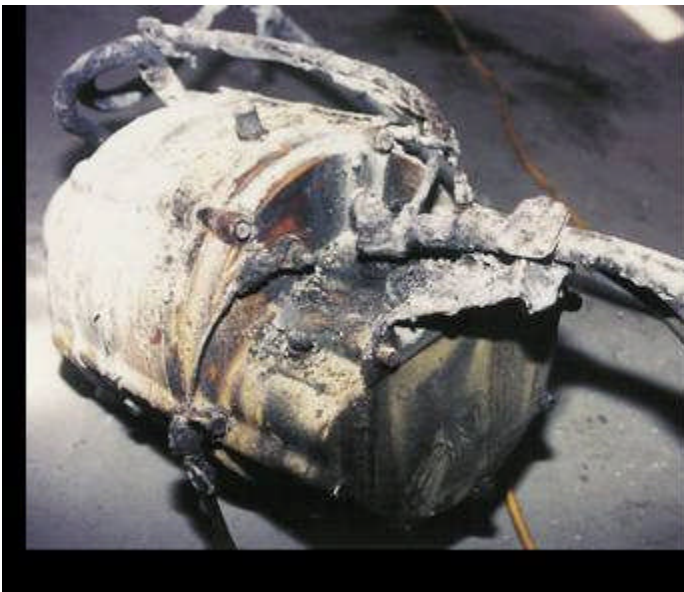
Photo 6b: 50-DN, Result of Failed B+ Stud Insulator

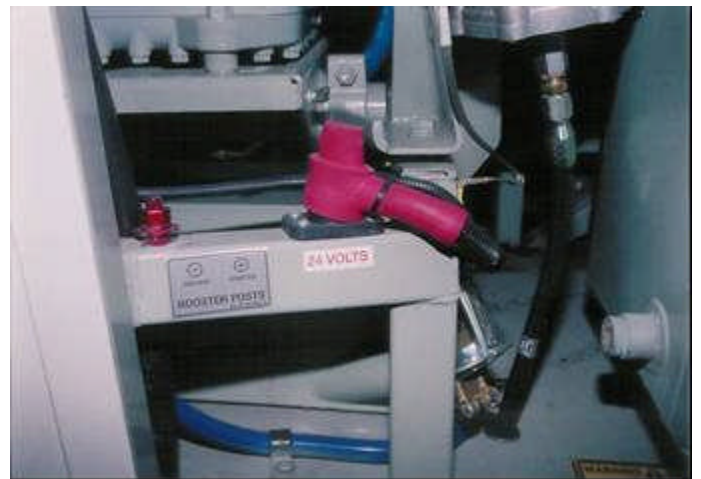
**Remote Jump Post:** With some applications a convenience feature is provided in the engine compartment for "jumping" a disabled vehicle. This is typically a positive (+) cable running from the starter to an exposed stud. These connections must be inspected and maintained to provide integrity. Additionally, this stud is covered with a flexible rubber boot (Photo 7).

Photo 7: Remote Jump Post

This boot must be in good condition and over the positive (+) stud at all times. A loose jumping stud/cable can create a sustained duration spark similar to the alternator B+ cable.

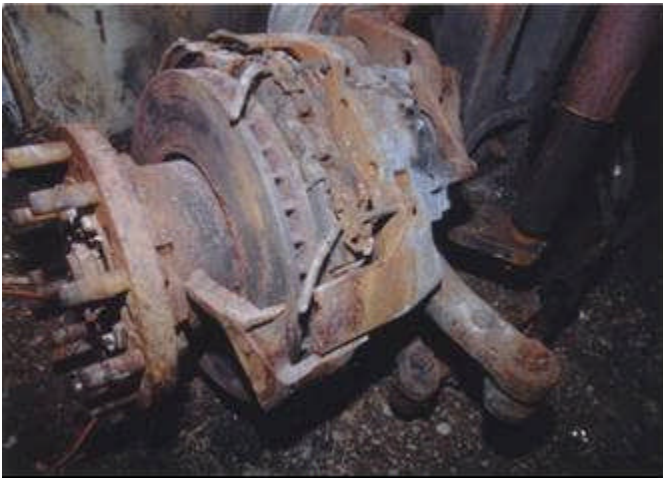
An additional risk exists, with disc brake applications, during a wheel bearing/hub failure. That is, as the outer bearing begins to fail, the hub load is transferred from the outer bearing to the brake caliper, brake pads and rotor. Once the outer bearing has failed completely, no longer able to support the hub load, the

caliper, brake pads and rotor are then supporting that particular wheel end (Photos 9 & 10).

Photo 9: Disc Brake (RH Tag Axle) [Involved]

Once the brake caliper begins carrying the load, at that particular wheel end, the surface temperature of the brake pads and rotor (or drum) rise well above the auto-ignition temperature of the surrounding combustibles (due to friction) and eventually igniting them. The combustible material typically ignited by this failure mode is the tire(s). Tires generally revert (melt) at approximately 250°F and catch fire over the 600°F mark. It is common, although not mandatory, for the tire fire to occur when the vehicle comes to a stop. This is the condition with the least amount of air flow circulating around the brake rotors, brake drums and tires. Without air flow around these items, their temperature rises rapidly and is transmitted to the tire—subsequently igniting it. This concept of brake caliper/pad/rotor supporting the hub load can typically be seen by a thinner more worn outside brake pad as compared to the inner pad. This is due to the hub moving outward, away from the spindle. As a result of this temporary load support from the caliper, the operator may continue to drive the vehicle without any indication of a problem until it is too late.

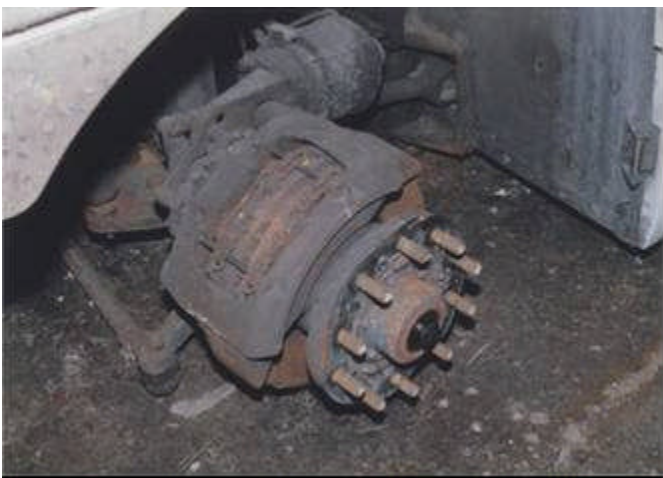
Photo 10: Disc Brake (LH Tag Axle) [Not Involved]

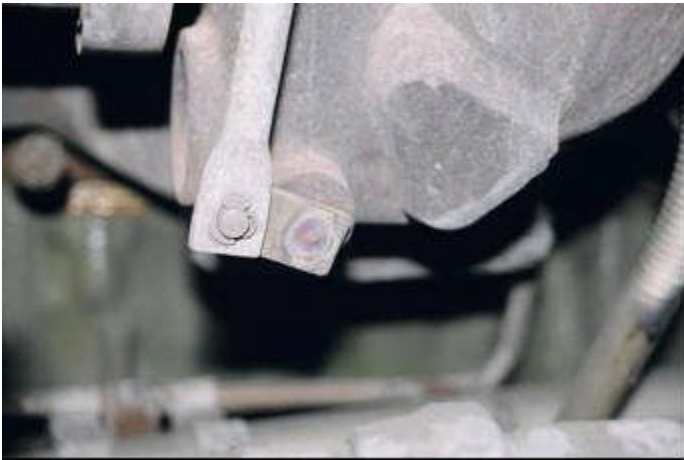
Specifically, blue smoke, due to oil consumption along with reduced engine torque will be noticed. Also a specific oil leak, from the waste gate pivot point, can be observed (Photo 14). Once oil has begun to leak from this point on the turbocharger it should be removed from service and the exhaust system should be thoroughly cleaned. To assist in preventing this failure mode; the turbocharger waste gate or variable geometry function (V.G.T.) must be confirmed. Additionally, the shaft free play, both axially and radially, must be inspected by a mechanic.

Photo 14: Waste Gate Pivot, Series 60

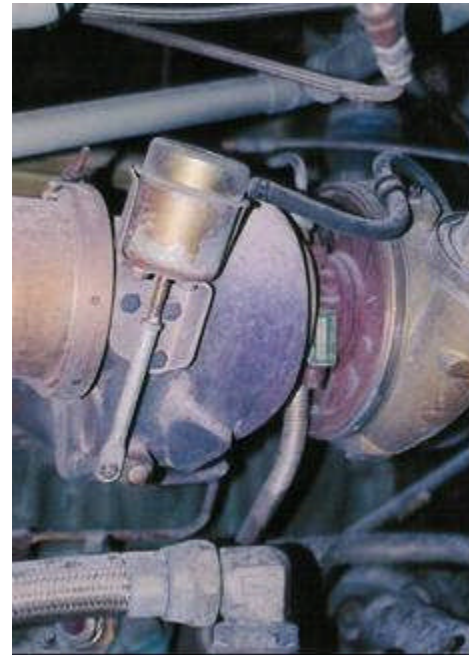
Photo 15: Waste Gate, Series 60

To confirm the function of the waste gate (Photo 15), apply regulated air pressure to the boost line (20-30 psi) to exercise the waste gate slave cylinder. To confirm the V.G.T. function (Photo 16), turn on the vehicles' ignition to "on" and observe the slave cylinder motion.

If there is no motion for either system upon these diagnostic tests, they are defective and must be replaced/repared. These two systems regulate turbocharger boost pressure. If they were to fail to regulate this pressure, it may lead to an internal failure thus leading to a fire.

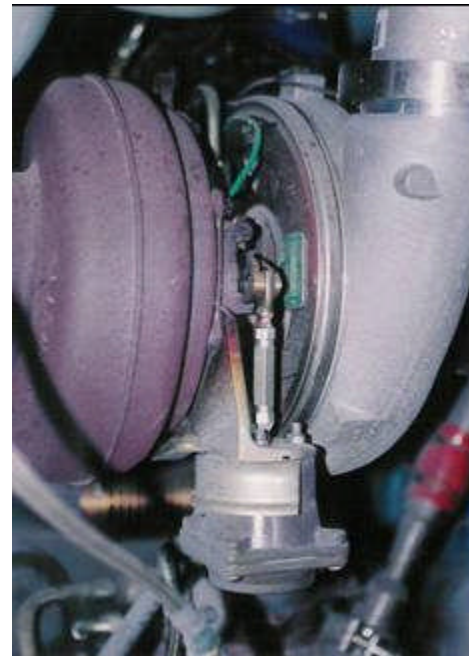
Photo 16: V.G.T., Series 60

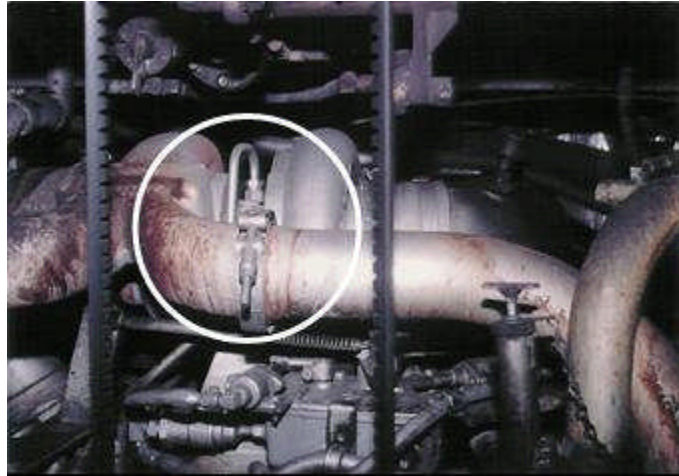
**External Turbocharger Oil Lines:** With the Detroit Diesel Series 92 application, there is only one external oil line. The oil supply line is positioned on top of the turbocharger and must be inspected periodically for leaks (Photo 17).

Photo 17: Turbocharger Oil Inlet Line, Series 92

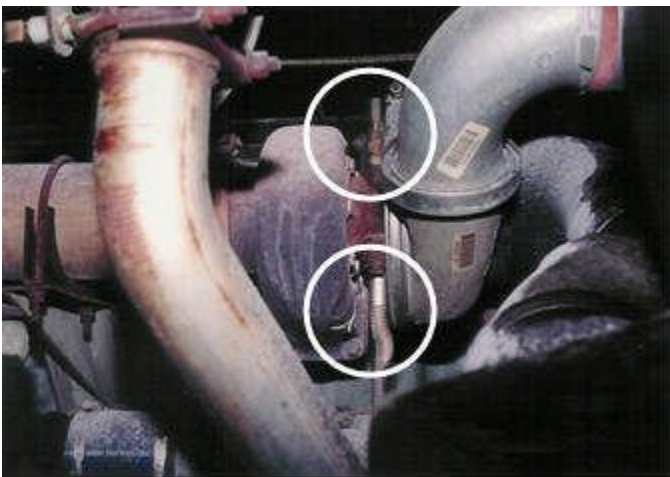
With most 4-stroke inline engine applications, the turbocharger has two oil lines which need to be periodically inspected (Photo 18). These turbochargers have an external supply and return oil line. In either case, a leaking oil line must be repaired to prevent an auto-ignition fire.

Photo 18: Turbocharger Oil Inlet Line, Series 60

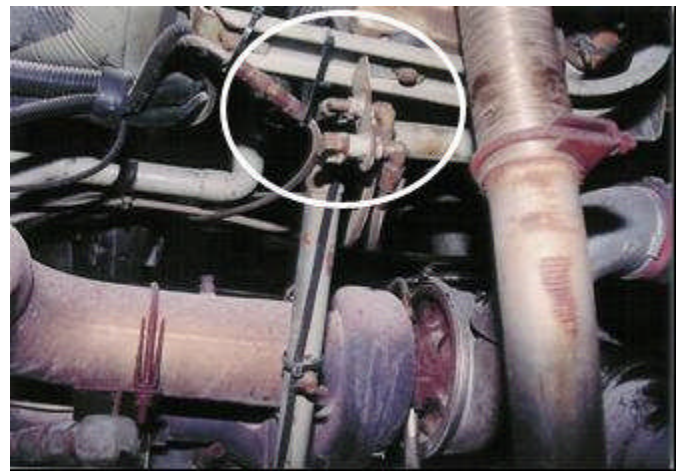
Photo 19: Looped Fuel Lines, Auxiliary Heater

**Auxiliary Heaters:** Also known as diesel furnaces, auxiliary heaters heat the onboard coolant when the engine is not running. However since it is a furnace which burns diesel as fuel it must be periodically inspected for function, control and integrity. Specifically, its cycle time and control must be verified to assure it is functioning when it should be, as well as, turning off when commanded. Additionally, the fuel lines must be inspected to confirm there are no leaks. In fact, in the summer months it is good practice to disconnect the heater function power supply and loop the supply and return fuel lines together (Photo 19).

This will assure that fuel does not leak from the furnace itself when not in service. It should be pointed out that the heaters' exhaust pipe (Photo 20), within minutes of heater activation, reaches 375°F and continues to climb approaching the auto-ignition temperature of most of the vehicles fluids.

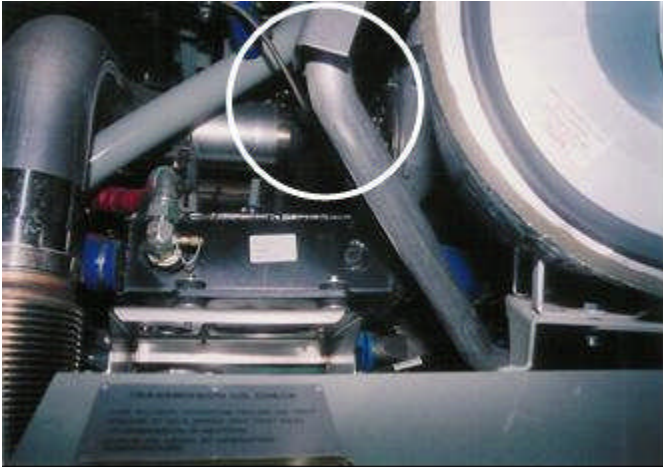
Photo 20: Auxiliary Heater Exhaust Pipe

Therefore, it is vital that any leak, of any fluid in this area, be immediately repaired to minimize high temperature contact and subsequent fire.
