# Safety Engineering & Risk Analysis Division

3<sup>rd</sup> Quarter 2008

#### Fire Investigations: Why Motorcoaches May Burn (A Mechanical Analysis)

Article Submitted By: Christopher W. Ferrone  
ARCCA, Inc.  
Chicago, IL  
Cell: 773.858.4941 / Tel: 312.676.2960  
Email: cferrone@arcca.com

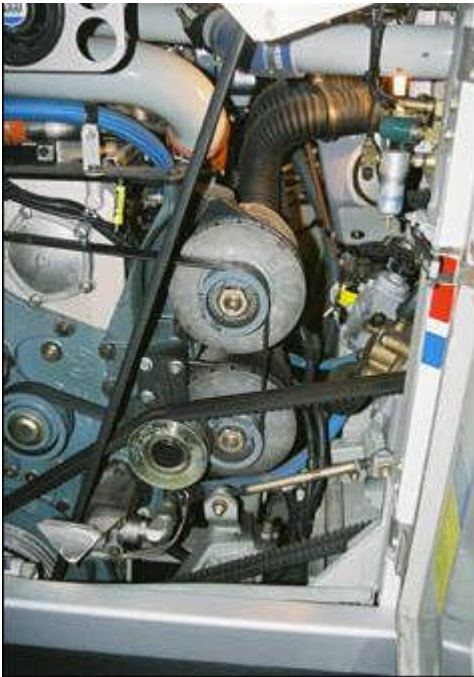
Photo 3b: Bosch T1, Series 60

**Alternator:** Most motorcoaches use either a large oil cooled gear/belt driven alternator or a more conventional style alternator similar to an automotive application; but larger. The typical varieties are a Delco 50-DN (Photo 3a) or an air cooled dual Bosch T1 (Photo 3b) configuration. The author must stress that these manufacturers are not being singled out for any particular reason; however, they are the most commonly found units within this type of vehicle. For most applications, the charging system for the motorcoach produces 275 amperes or more – as much amperage as a typical single family home may have. With this, the alternator (and system) carries great potential as an ignition source.

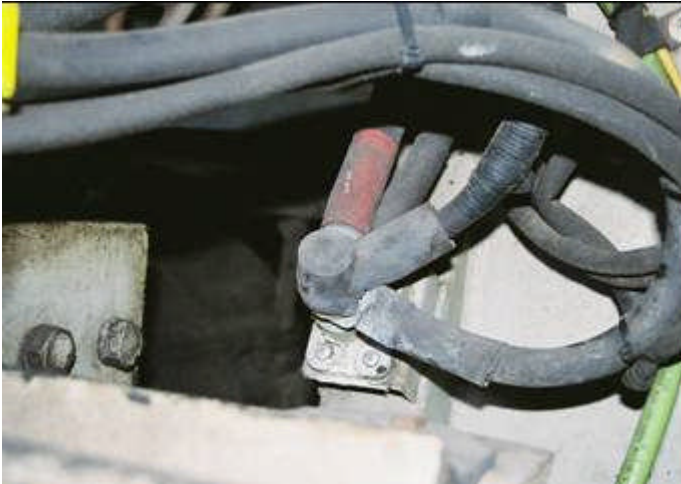
Photo 8a: Bulkhead Connection 50-DN

**Starter:** Most motorcoaches use either a Delco 42MT or 50MT starter. Under normal circumstances the starter draws 800 to 1000 amps respectively while cranking the engine. When it is not cranking the engine (no current flow) it is simply exposed to battery voltage. As with the alternator, the starter is connected to the batteries via a B+ (direct battery feed) cable. It too is routed to a stud on the starter motor. However, this is initially routed to a bulkhead junction (Fig. 3; Photos 8a & 8b); again this is a heavy cable and must be properly connected and supported in its mounting.

Care must be given to the cable condition, cable to starter connections, as well as its' routing so that this B+ cable is not making unwanted contact and potentially coming in contact with ground as a result of an insulation breach.

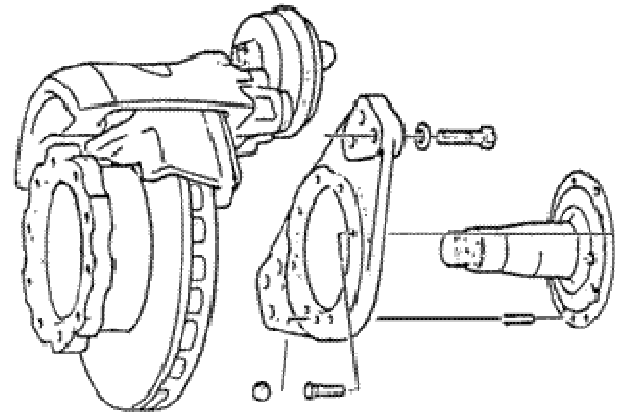
Fig. 4: Disc Brake, Caliper, Spider & Spindle

This is due to the fact that the caliper rides in the caliper carrier which is attached to the spider which is mounted to the axle tube/spindle (Fig. 4).

Once the brake caliper begins carrying the load, at that particular wheel end, the surface temperature of the brake pads and rotor (or drum) rise well above the auto-ignition temperature of the surrounding combustibles (due to friction) and eventually igniting them. The combustible material typically ignited by this failure mode is the tire(s). Tires generally revert (melt) at approximately 250°F and catch fire over the 600°F mark. It is common, although not mandatory, for the tire fire to occur when the vehicle comes to a stop. This is the condition with the least amount of air flow circulating around the brake rotors, brake drums and tires. Without air flow around these items, their temperature rises rapidly and is transmitted to the tire—subsequently igniting it. This concept of brake caliper/pad/rotor supporting the hub load can typically be seen by a thinner more worn outside brake pad as compared to the inner pad. This is due to the hub moving outward, away from the spindle. As a result of this temporary load support from the caliper, the operator may continue to drive the vehicle without any indication of a problem until it is too late.

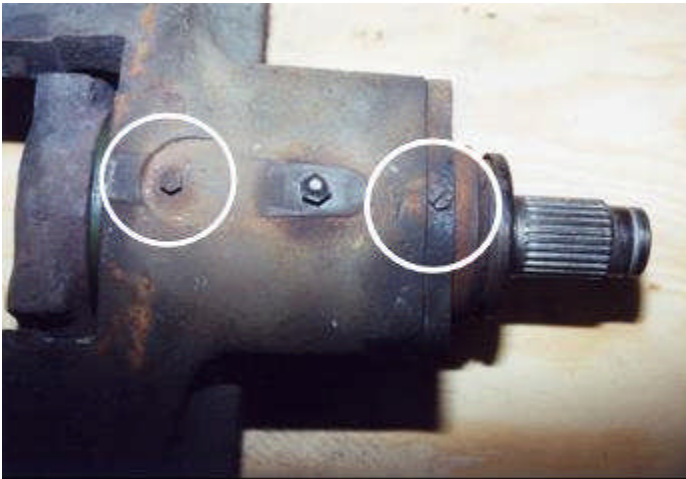
Photo 11: Rockwell Caliper ADB-1560

**Disc Brakes:** A “frozen” disc brake caliper can generate enough heat to ignite the surrounding combustible materials and sustain a fire. Proper inspection and lubrication intervals should be adhered to along with a periodic activation and release sequence confirming that the calipers are releasing and allowing the rotor to turn freely. This scenario applies to both air and hydraulic disc brakes. A simple method to determine the proper action of the calipers is to insert a feeler gauge (.002” - .004”) between the brake pad and rotor. By applying the service brakes a technician can feel if the gauge goes into this space, remains there upon brake application and is then released upon release of the service brakes. In some early applications, Rockwell disc brakes were used which in some instances were not supplied with grease fittings in the calipers (Photo 11, Fig. 5). This very point leads to a “frozen” caliper scenario which, in the author’s direct experience, results in a fire at that wheel end.

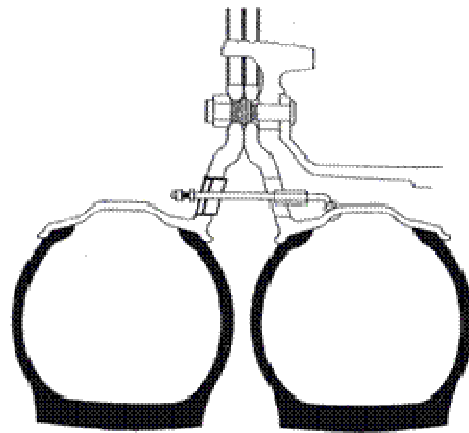
Fig. 6: Cross Section View of Dual Tires

If the adjacent tire is under-inflated the gap closes and the tires begin to “kiss”. Since an under-inflated tire only bulges at the road surface, a cyclical contact event occurs between the inflated tire and the under-inflated tire. Over time this cyclical contact may generate heat increasing the tires temperature. Therefore, operators should always ensure that all tires, especially dual tires, are inflated and not in contact with one another. In general, operating temperatures for radial tires can be anywhere between ambient plus 60°F (150°-180°F). Under severe conditions the operating temperatures will range in the 200°F areas [3].

**Tires:** A flat or under-inflated dual tire can become a fire hazard and in some cases go undetected. Dual tires are spaced apart to provide a gap (Fig. 6).
